## Emergency Restoration to Rabbit Branch

By Greg Sykes ([greg@grsykes.com](mailto:greg@grsykes.com))

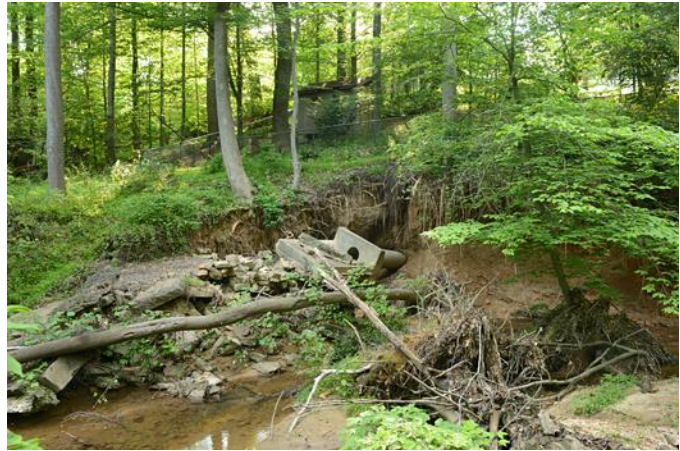
**Figure 1.** This “before” image reveals the destroyed storm drain outfall and massive erosion next to private property.

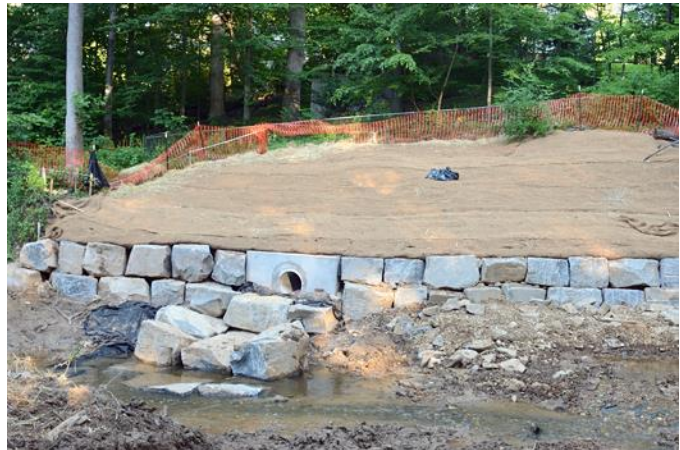
**Figure 2.** The “after” shot of the restored area shows a new outfall where stormwater hits stone boulders. A rock wall protects the hill from churning floodwaters. Until native restoration plants arrive, coir and straw promote grass growth that retains the soil. The county and other institutions are getting away from synthetic lawn netting since it inevitably becomes another source of plastic waste polluting the environment.

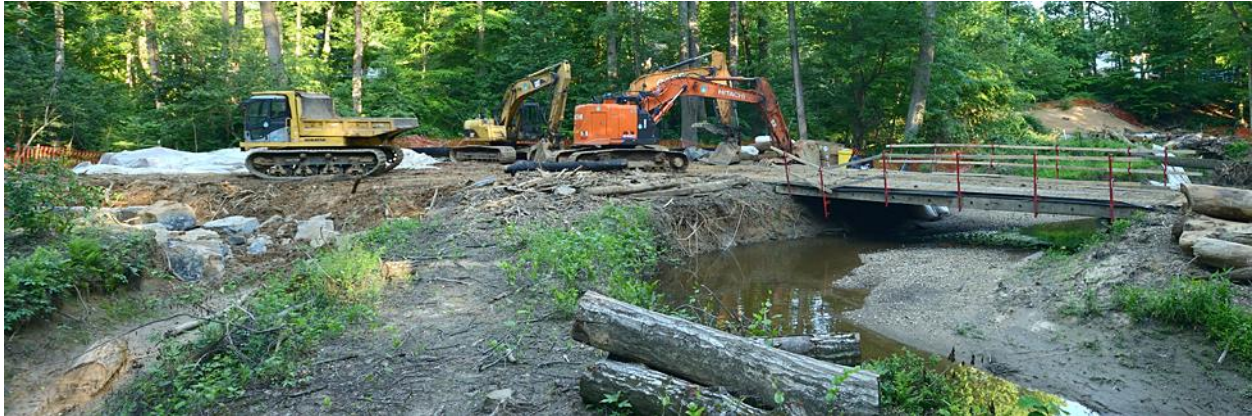
**Figure 3.** A temporary bridge enabled earthmovers to cross Rabbit Branch and perform work upstream. Boulders on the left await placement in repairing the water's course from a storm drain outfall. Logs from fallen trees (center) will integrate into the stream bank and provide favorable habitat for aquatic life.

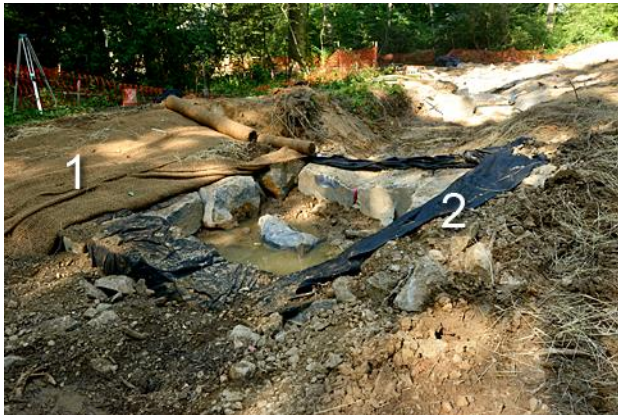
**Figure 4.** Restoration typically goes in a downstream direction. This incomplete section shows the coir nets (1) unrolled to retain soil. Whereas the county is moving away from plastic materials in restoration projects, synthetic geofabric (2) lines the waterway bottom with boulders and pebbles on top.

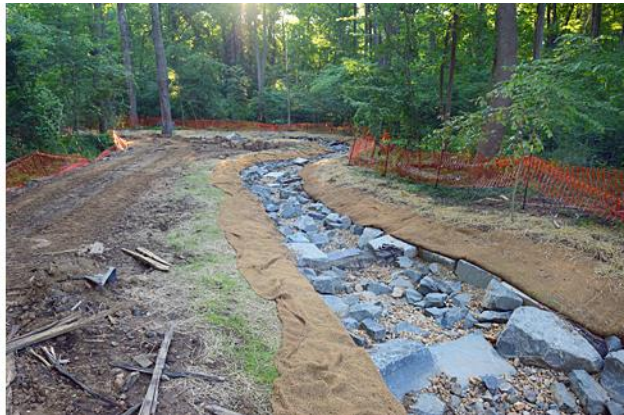
**Figure 5.** Near the outfall, the waterway is finished. Boulders and a curved course reduce the rushing storm water's energy. The interim roadway (left) remained in use until completion of all major earthmoving activities.

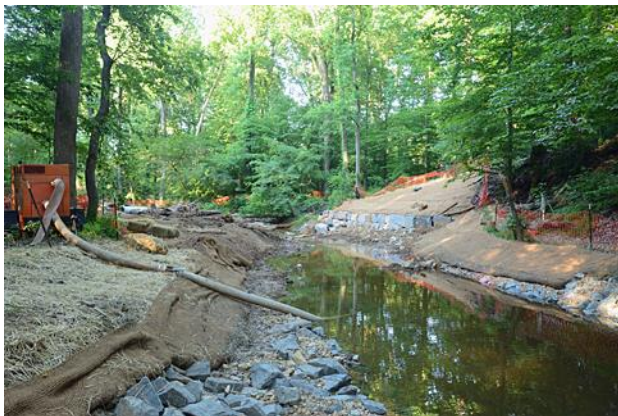
**Figure 6.** To temporarily reduce the creek's water level for work on that stretch, a pump (left) bypassed water to a down-stream location. Daces and other minnows soon returned.

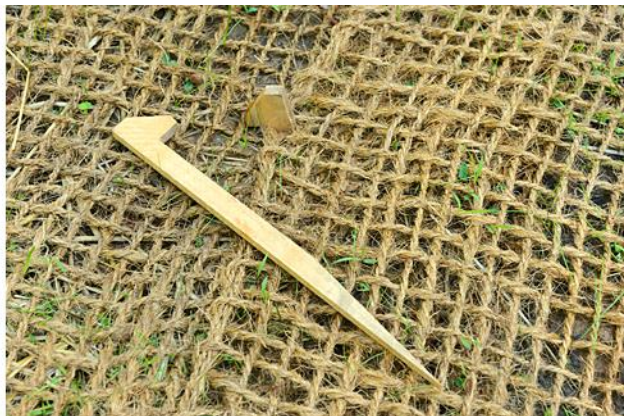
**Figure 7.** To help the grass grow, scattered straw on bare ground is held by a biodegradable coir net. Wooden stakes secure the net, which protrude and therefore are used away from traipsing hikers.

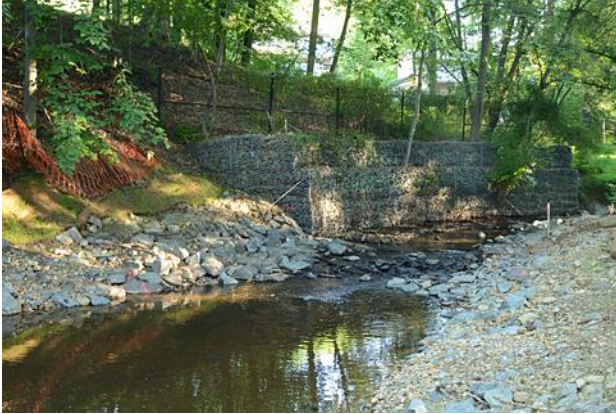
**Figure 8.** The restoration's upstream terminus (left) used modern approaches to replicate a natural creek. It is a more conducive environment for aquatic life than the gabion walls (center) to control bank erosion, which were installed decades earlier. This wall and the concrete-lined portions of creek bed with "speed bumps" (not seen here) are outdated waterway control methods.

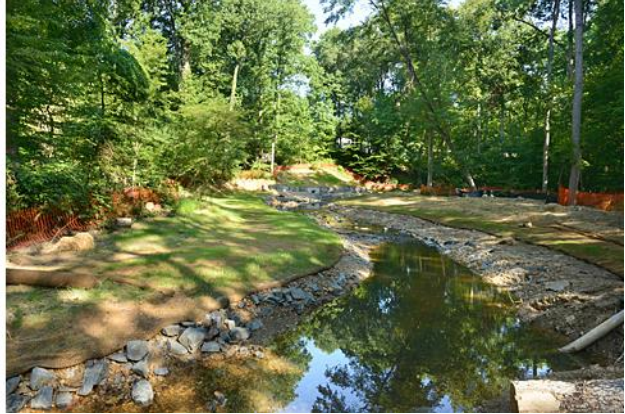
**Figure 9.** The preliminary work for this stream restoration is done. A shallow streambed allows water to dissipate energy across a wide surface. Grass is already sprouting along the banks. The orange work zone fence will soon come down. After adding native plants in the cool-season months, the reforestation begins—a process that continues for many decades.
