Completing Shanes Creek's Stream Restoration: Part 1

By Greg Sykes (greg@grsykes.com)

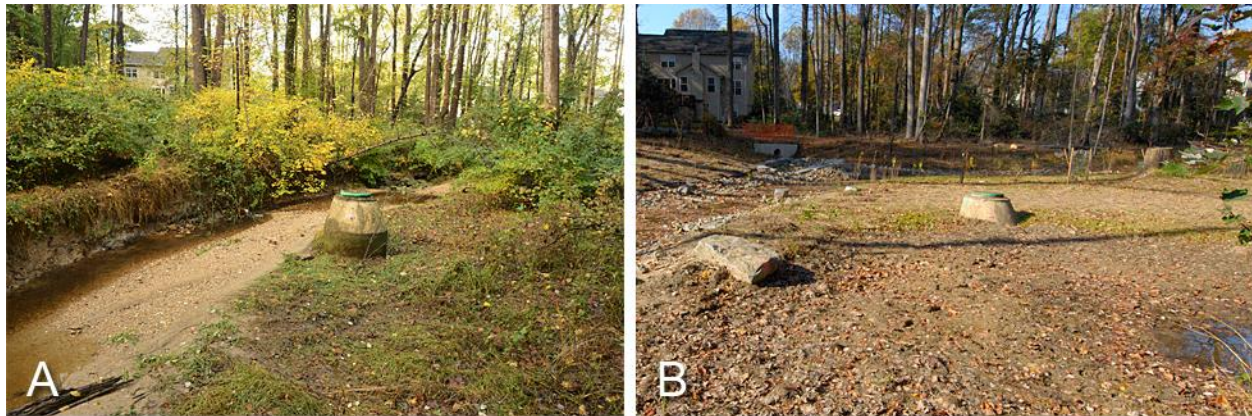
Figure 1. A major factor driving the stream restoration was Shanes Creek's heavily eroded and sunken streambed (A), also seen in some of its tributaries. Years earlier, the creek flowed to the right of the then mostly buried sewer manhole tower. The project elevated streambeds and water tables (B, photographed at the same location after restoration). Some sections were rechanneled. Strategic combinations of stones, logs, and native plants now line and reinforce the streambanks. The concrete-filled, four-inch-diameter PVC tubes are permanent stream stability monitoring stations (C), installed at several places along the restored waterway.

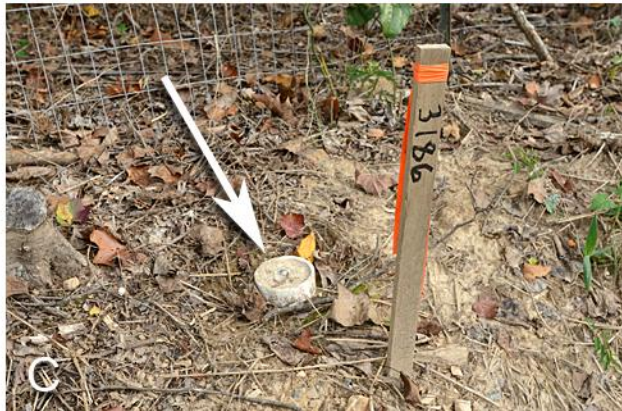
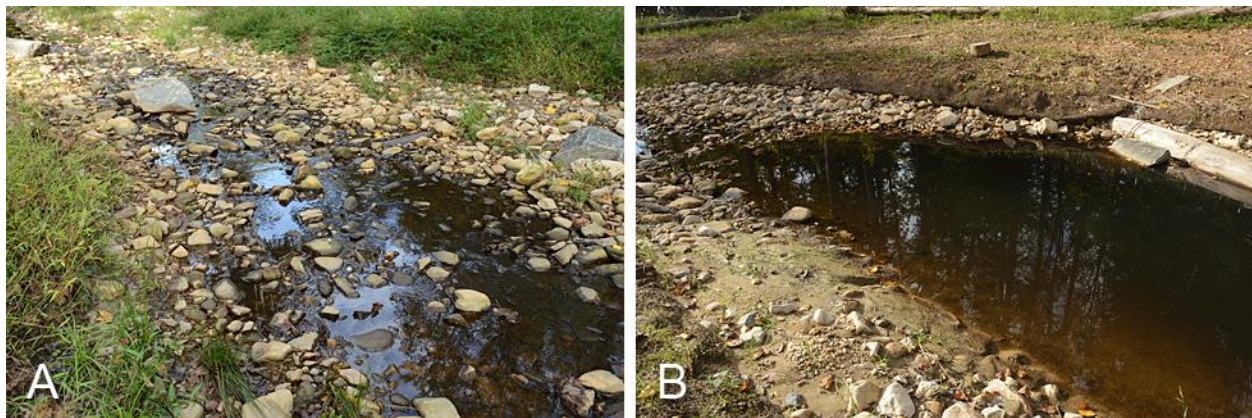
Figure 2. Much of the creek has either shallow rocky areas called riffles (A) or deep pools (B). The water running through the riffles gets oxygenated while the pools offer cooler spots for heat-sensitive critters. You can play a vital role in the restoration effort! Please leave all stones where they are because they serve important purposes such as stabilizing the streambed and holding the underlying geotextiles in place that could otherwise washout during a severe storm.

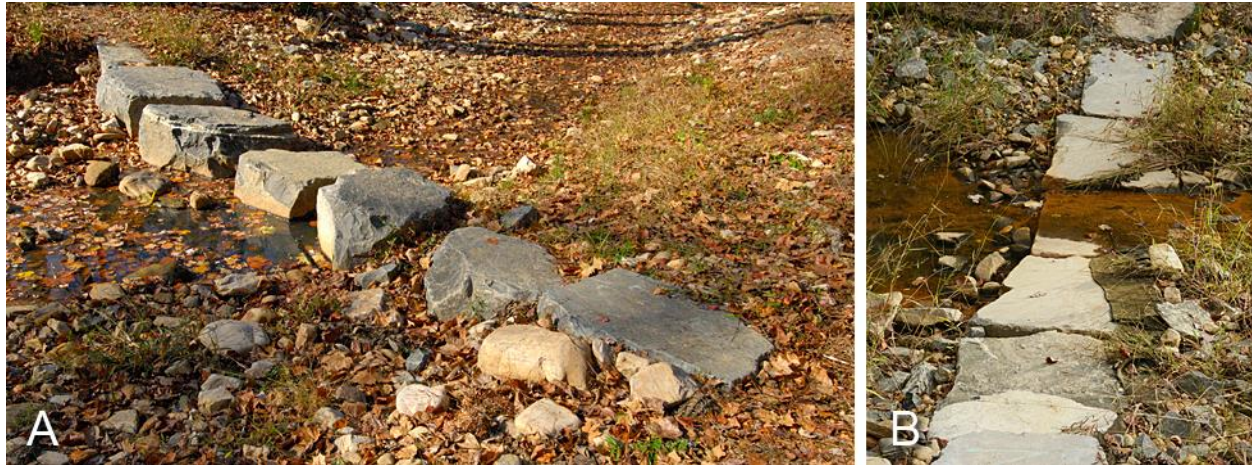
Figure 3. The pre-restoration bridge across Shanes Creek was removed. Where trails cross the stream, elevated, fair-weather steppingstones are in place (A). Plan your walk accordingly if heavy rain is in the forecast. Carved, partially submerged boulder arrangements called “sills” (B) control the stream. They might look like rustic sidewalks but are not and can be dangerously slippery with algae. Please stay off the sills. Water levels are low in both images due to a drought.

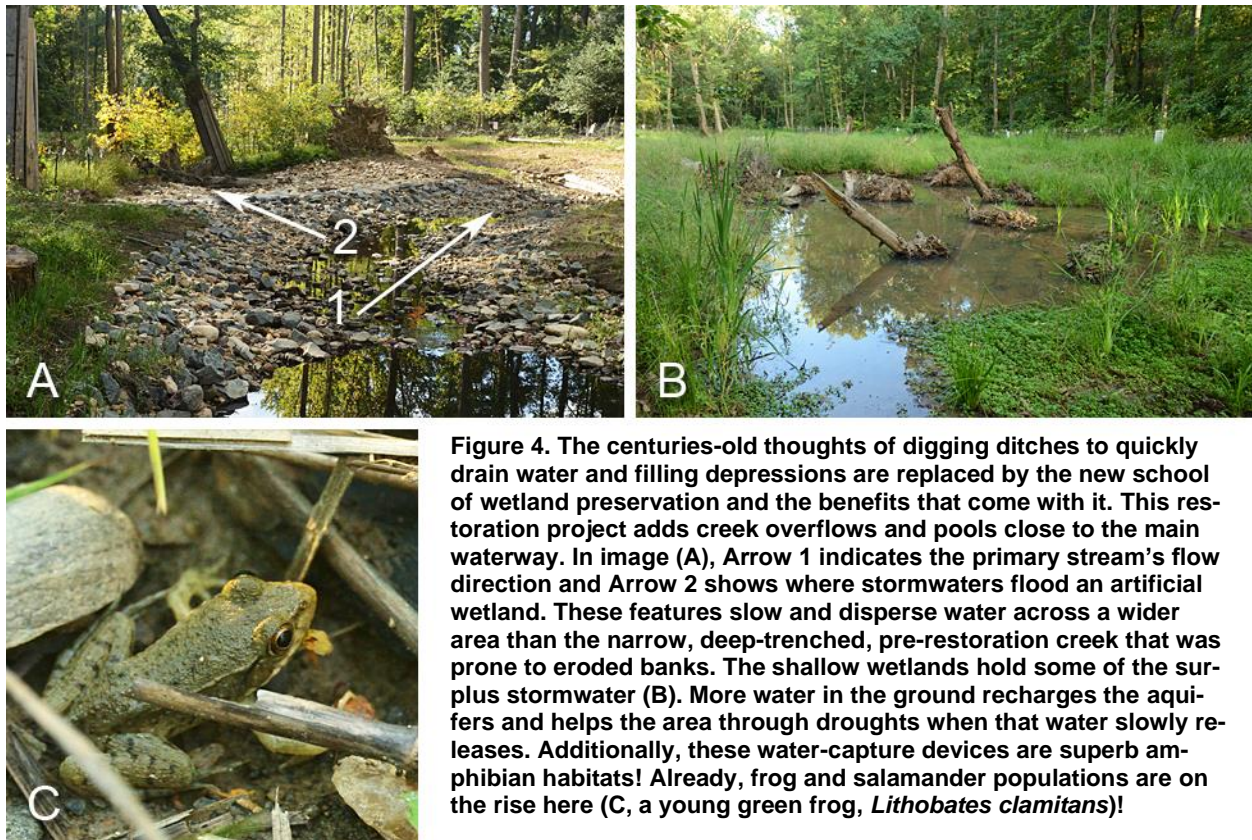
Figure 4. The centuries-old thoughts of digging ditches to quickly drain water and filling depressions are replaced by the new school of wetland preservation and the benefits that come with it. This restoration project adds creek overflows and pools close to the main waterway. In image (A), Arrow 1 indicates the primary stream's flow direction and Arrow 2 shows where stormwaters flood an artificial wetland. These features slow and disperse water across a wider area than the narrow, deep-trenched, pre-restoration creek that was prone to eroded banks. The shallow wetlands hold some of the surplus stormwater (B). More water in the ground recharges the aquifers and helps the area through droughts when that water slowly releases. Additionally, these water-capture devices are superb amphibian habitats! Already, frog and salamander populations are on the rise here (C, a young green frog, *Lithobates clamitans*)!
